* "PALFIQUE LX5" is sold in Japan under the name "ESTELITE Σ QUICK".

Long-Term Clinical Case of Anterior Restoration

Dr. Shigehisa Inokoshi Private dental practice in Tokyo -Japan

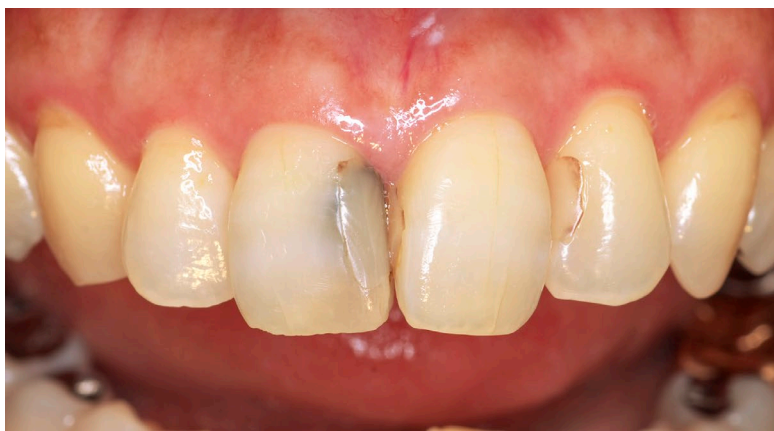
Before procedure. September, 14, 2009

Female (59 years old): Chief complaint of discoloration of the maxillary anterior teeth.

A large Class III CR filling was present at the mesial proximal surface of #11, and secondary caries was noted on the cervical side of the tooth, probably due to microleakage. Class III CR filling was also present at the mesial proximal surface of #21 and #22, and a discolored line was seen along the margins.

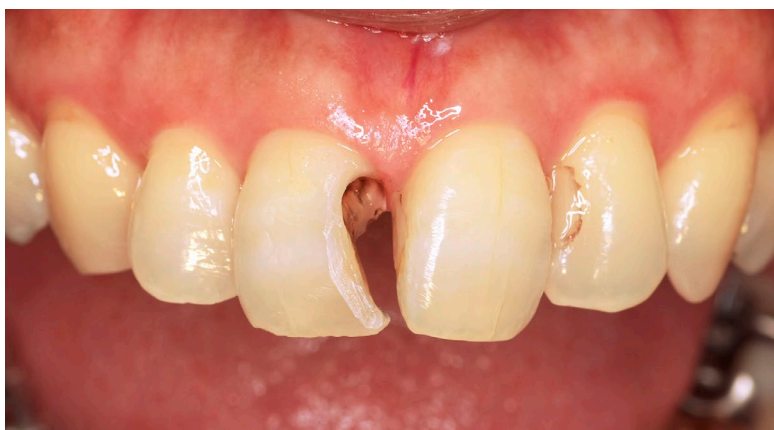
After cavity preparation.

The conventional restoration of the mesial proximal surface of #11 was removed, and further carious dentin was removed under the guidance of a caries detector. The dark discoloration observed on the cervical area exhibited a hard surface and did not stain with caries detector; it was left intentionally to avoid extending the cervical margin into the subgingival area.

A wide bevel was attached to the labial margin. The composite resin of the mesial part of #21 was polished again removing the discoloration at the labial margin as much as possible.

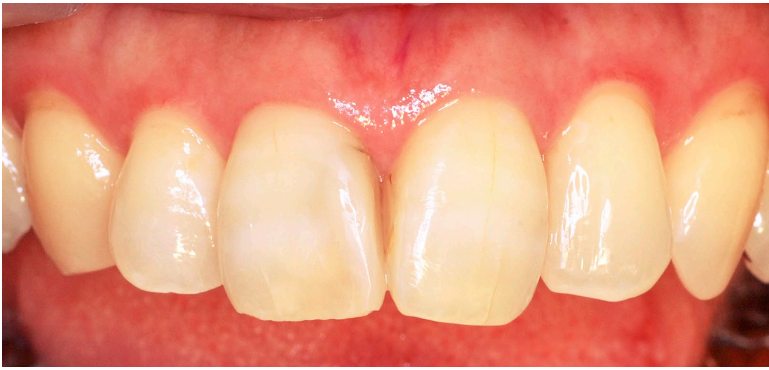
After final polishing.

The mesial part of #11 was filled with ESTELITE SIGMA QUICK (A2) and final polishing was performed on November 2, 2009. At the same time, the previous CR filling in #22 mesial part was removed and the area also filled with ESTELITE SIGMA QUICK (A2), with polishing performed the same day.

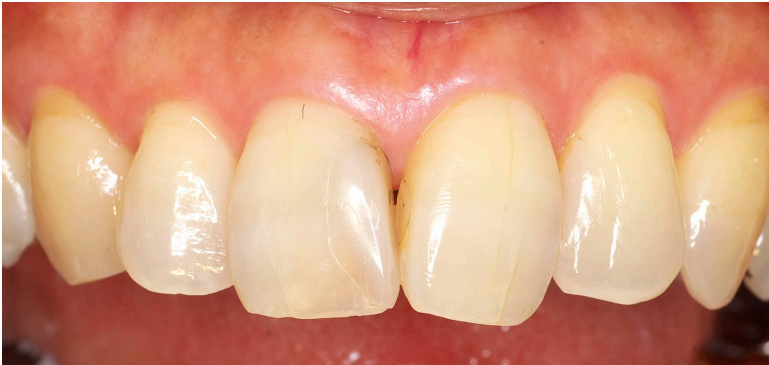
After 5 years.

On October 24, 2014, 5 years later, the filling surface was polished again. The luster of the filling in both #11 and #22 was maintained without any discoloration.

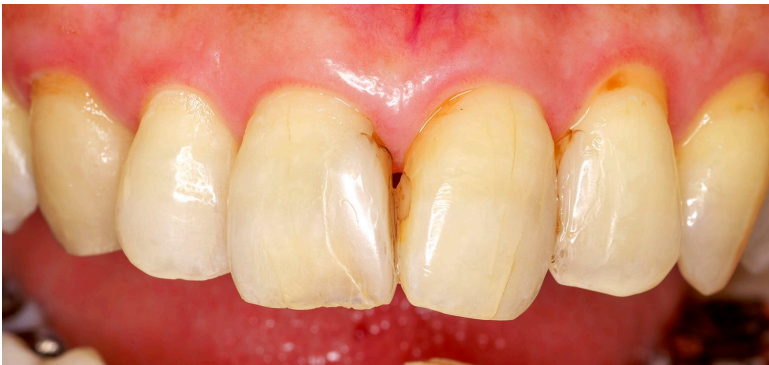
After 15 years.

On December 14, 2024, 15 years later, the filling surface was polished again. Some discoloration is observed at the cervical margins of #11 and #22 which is difficult to reach with the polishing tools, but the luster of the filling material surface is maintained without discoloration.
